# Kona Soil and Water Conservation District

**RE: Storm Event of May 6, 2011**

# PHOTO DOCUMENTATION FORM

These photos were taken on 6/2/11 during a flood control structure tour. On 5/6/11 there was a storm event that brought more than 6 inches of rain to this area in less than 3 hours. This was an inspection requested by property owners who have these structures within their parcel.

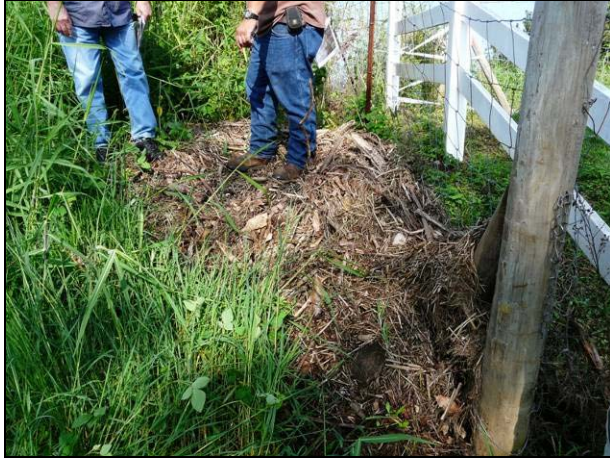
Description: GPS points 322 & 323 on map. This picture shows the debris that collected at Ken Springer's fence. The modifications made to his fence worked and water was allowed to flow under it.

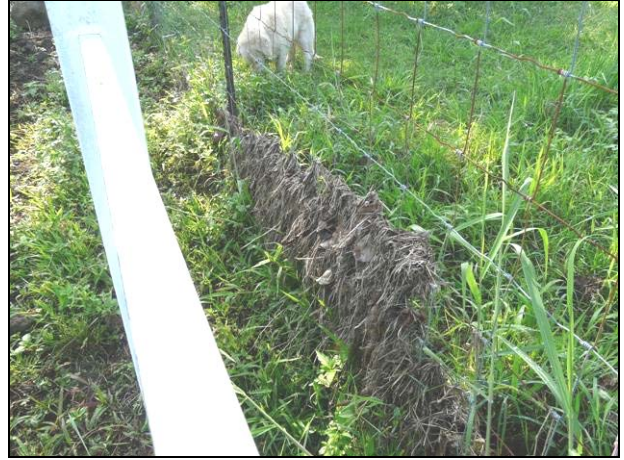
Description: This is on the fence on eastern side of the gate, note the debris.

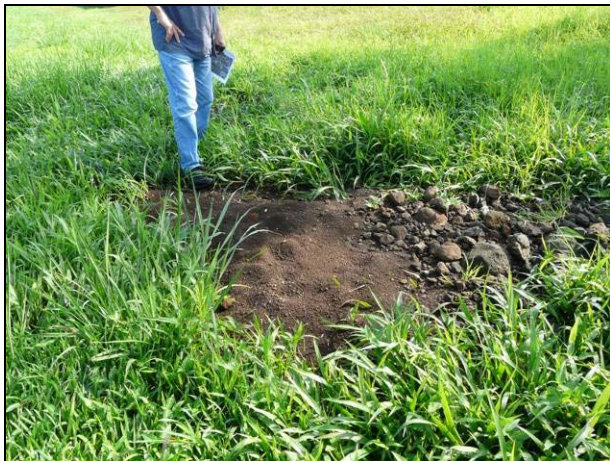
Description: Sediment that collected within the flood control structure. The entire channel should be checked for grade and sediment should be removed where needed. All bare areas should be reseeded with an appropriate grass species.

It is recommended that the county's Department of Public Works remove sediment from diversions KD-4 and KD-5. In KD-4 there is grouted rock rip rap at the southern end some depth of which is likely to be covered up. In diversion KD-5 ground level should be lower than the box inlet. This will allow sediment to fall out of suspension so that cleaner water can enter the box inlet preventing debris from creating an obstruction within the box or the lava tube the box empties into.

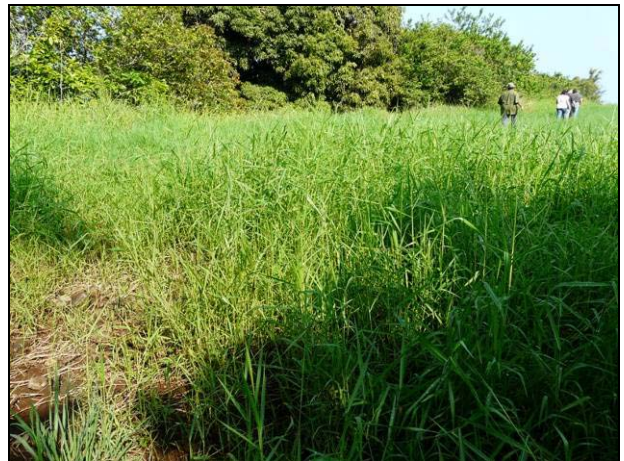
Description: Looking northerly through the flood control structure. The grass is in need of cutting.

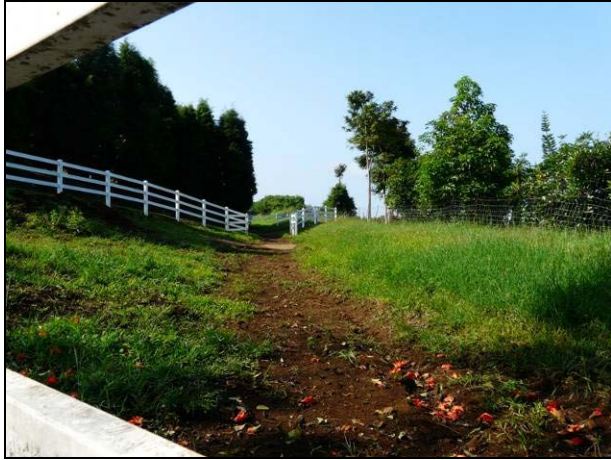
Description: This picture was taken at GPS point 324 and is looking southerly. At the opening in gate seen in the distance is a road that cuts through the flood control structure. Beyond that is the grassy area shown in the previous picture.

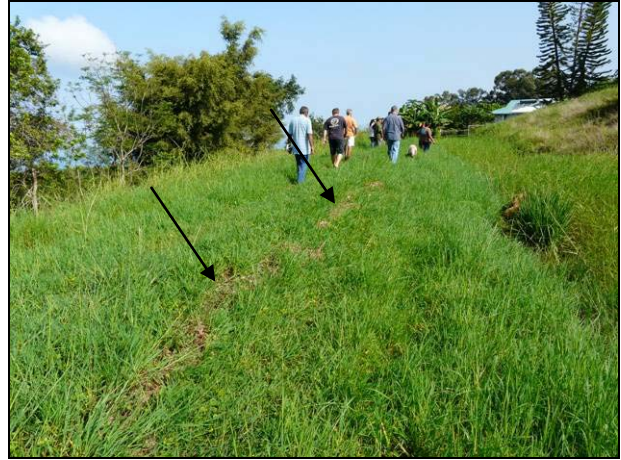
Description: Heading northerly through the flood control structure. In the left hand corner of the photo is roof. This is the area of the concrete channel that brings flood water into a lava tube/cave, note the line of debris, indicated by black arrows, caused by high water. It is believed this grass swale has to be dug out so that meets its original capabilities.

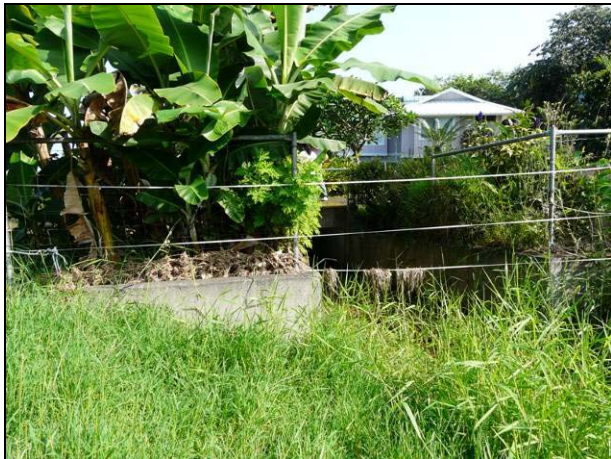
Description: This is the end of the grassy area shown in the previous photo. It is the beginning of the concrete channel that flows into a lava tube/cave.

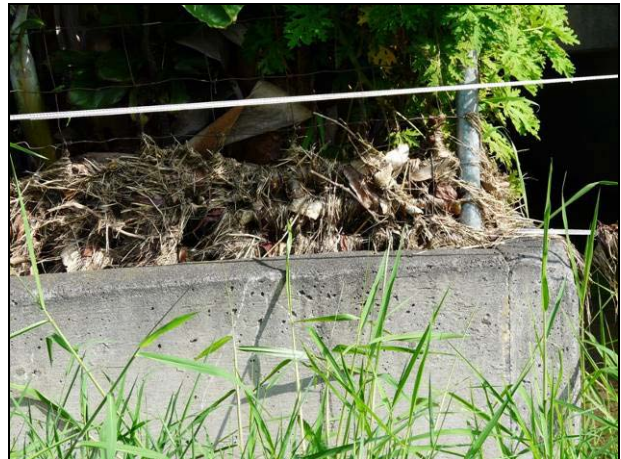
Description: This is a close-up of the debris collected along a fence at the beginning of the concrete channel. Debris collected in the fence is approximately one foot above the concrete structure.

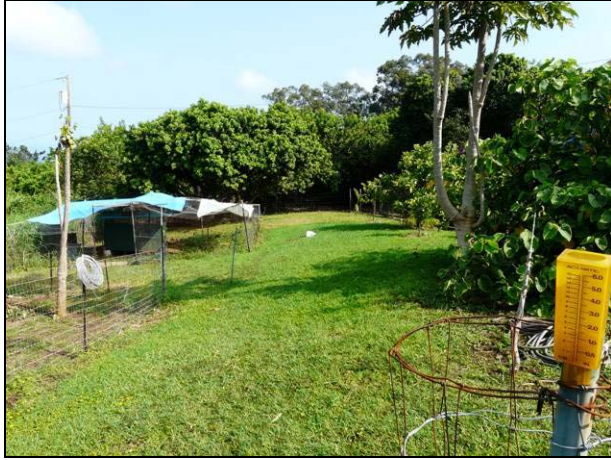
The Kona SWCD found that the watercourses did not contain all of the rainwater. It is believed this was primarily the result of the volume of rain. At the northern end of flood control structure KD-4 a resident's rain gauge with 6" capacity overflowed in less than 2.5 hours. This was at the 1800' elevation. There was some overflow at this end of the structure.

Description: This picture shows the rain gauge that was over topped during the storm event on 5/6/11. This picture at GPS point 325. At the end of the grassy area is the fenced off area where the concrete channel flows into the lava tube/cave.

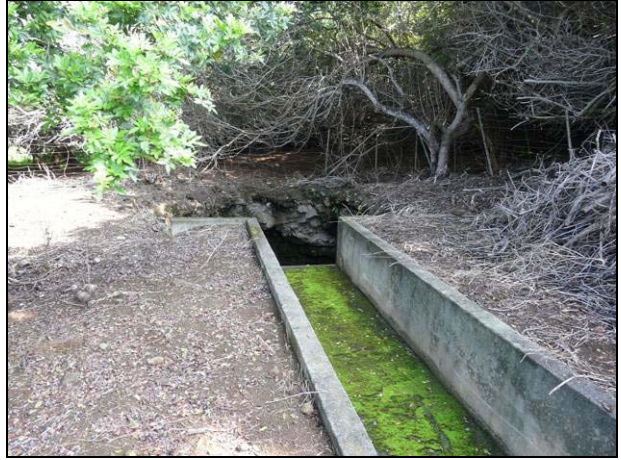
Description: This shows where the concrete channel enters the lava tube/cave. This picture was taken at GPS point 326.

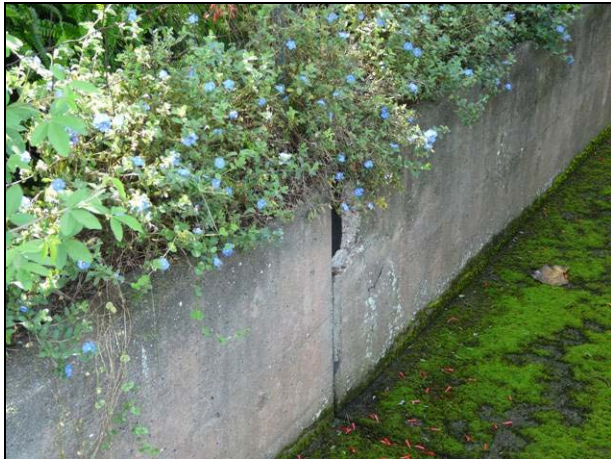
Description: A hole in the side of the concrete channel. This is expected to be repaired.

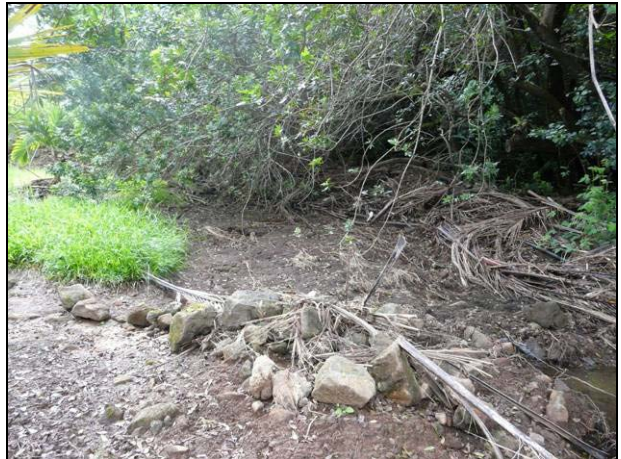
Description: Picture taken from GPS point 328. It shows where the water came onto the property, looking north easterly.

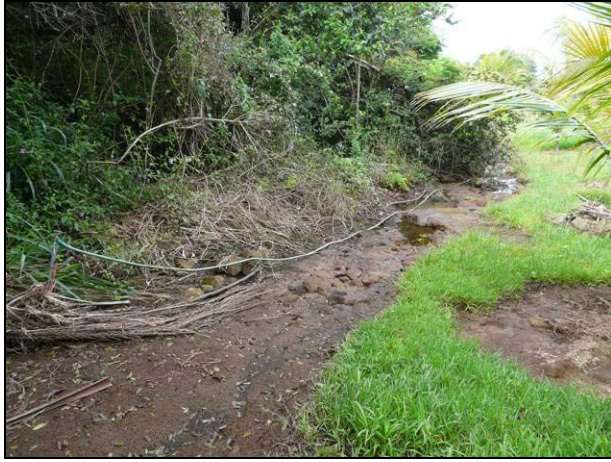
Description: Where the water went from GPS point 328.

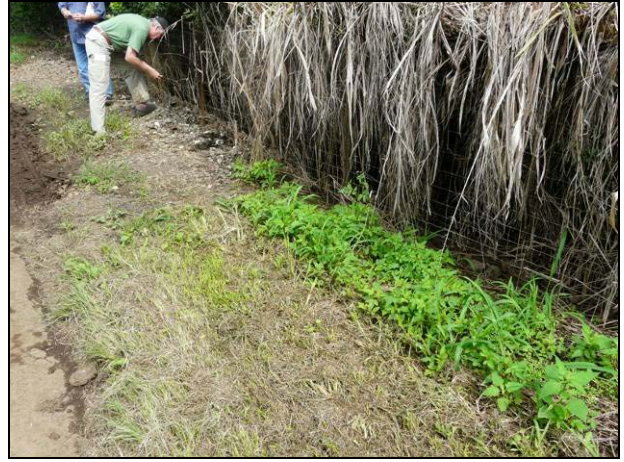
Description: GPS point 329, where the county used to access a flood control structure. Due to a fence and extensive christmasberry growth they are no longer able to do so. They plan to dig out some of this so that water can flow more easily into the sediment basin area from the road instead of traveling down the road.

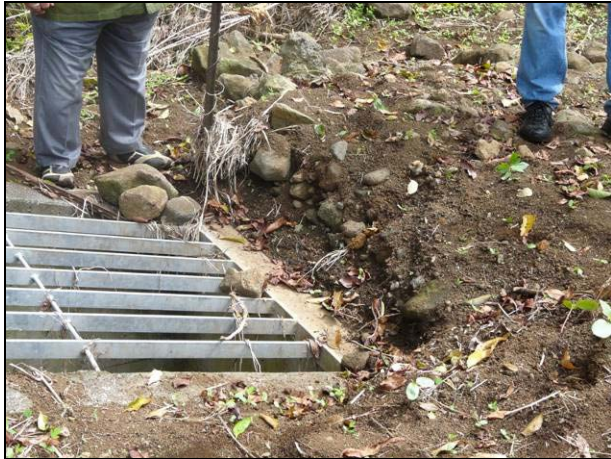
Description: Flood control structure #3 at GPS point 330. After the 5/6 storm event .large boulders were covering this grate.

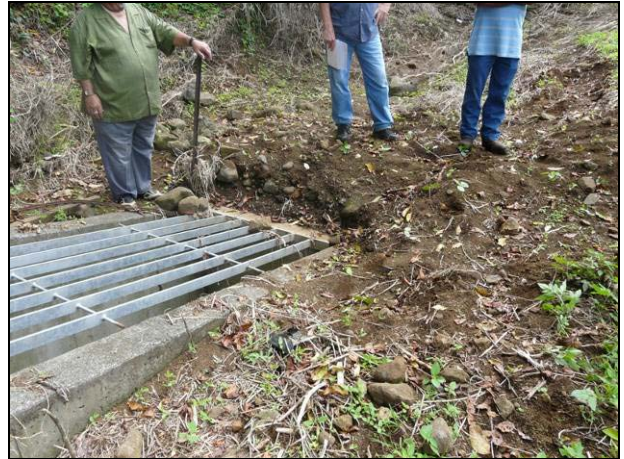
Description: Another shot of flood control structure KD-5. The shows the depth of sediment in front of the concrete lined pit. Normal sediment level should be approximately two feet below the inlet to the structure.

The Kona SWCD understands that the area around KD-5 will be a difficult area to work in to remove sediment due to the presence of lava tubes and potential hazards to Public Works Department work crews. We recommend smaller sized earth moving equipment be used in this area to minimize any potential threat to the work crews.

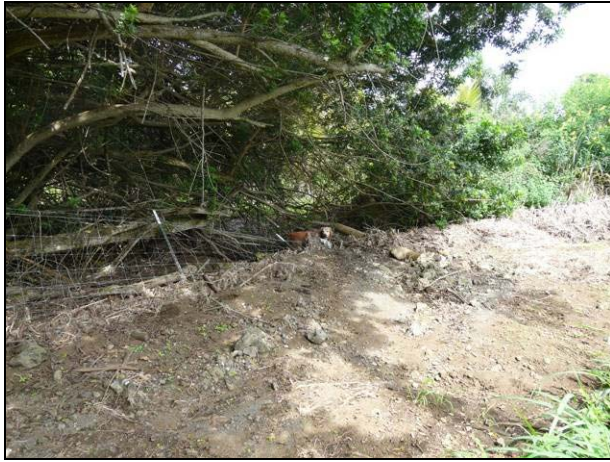
Description: Sediment and debris have damaged this fence. This is where water flowed (GPS point 331) from the sediment basin onto the makai property in the area of GPS point 328. It is believed this sediment basin needs to be dug out so that it meets its original capabilities.

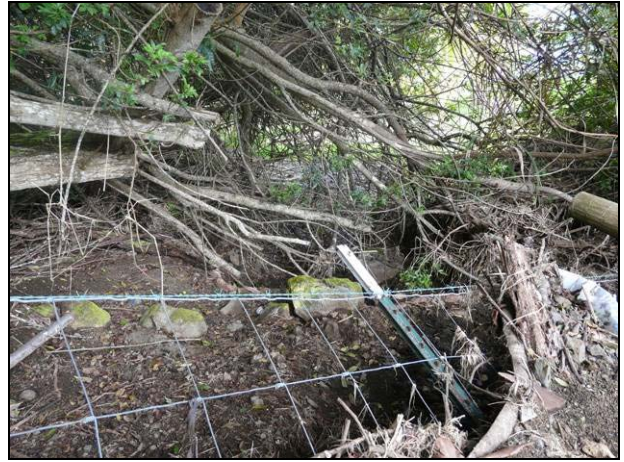
Description: A close up picture of the downed fence.

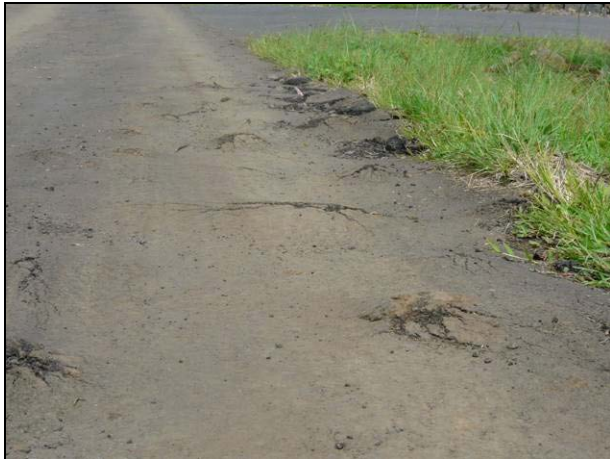
Description: Damage to the road caused by the 5/6 storm event.

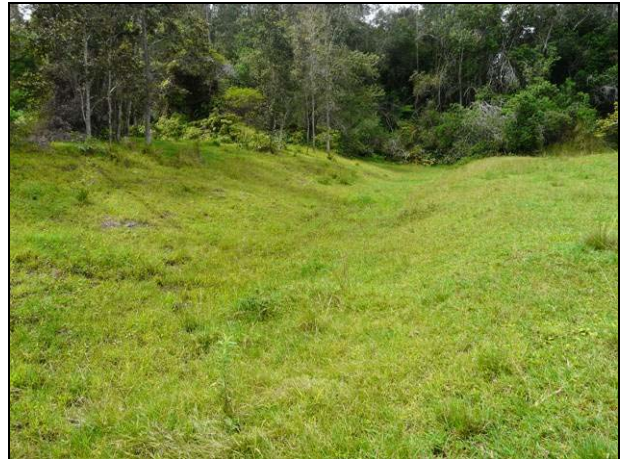
Description: The most mauka flood control structure visited on 6/2 KD-2. There is no sign of flooding, there is no debris line shown along the berms of the grassed swale. It is estimated only 1-2 inches of rain fell in this area on 5/6. This is GPS point 333.
