Kona Soil and Water Conservation District

Kona Soil and Water Conservation District Feral Pigs and Kona Soils

PHOTO DOCUMENTATION FORM

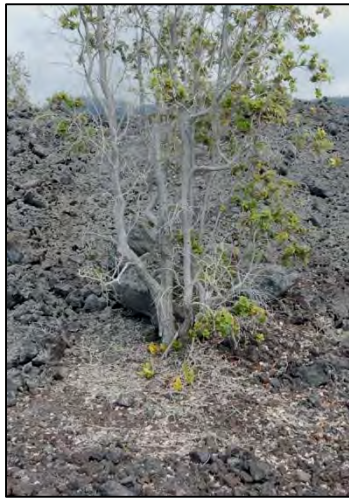
This 'ōhi'a tree is growing in an 'a'a lava field. The leaf litter under the tree is early soil formation. Mother Nature will take a long time and a lot of leaf litter to create a layer of soil. This lava flow is from the 1900s and came from Mauna Loa.

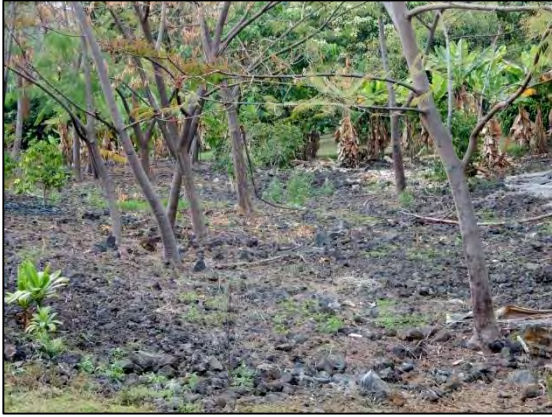
In 2007 this area saw a destructive flash flood. There was concentrated flows and sheeting across this area of S. Kona. Above is an area that saw significant erosion during that event.

What you are looking at are trees growing out of a field of rocks. There are some grasses growing and some leaf litter but even the pigs don't bother this place, there is no soil.

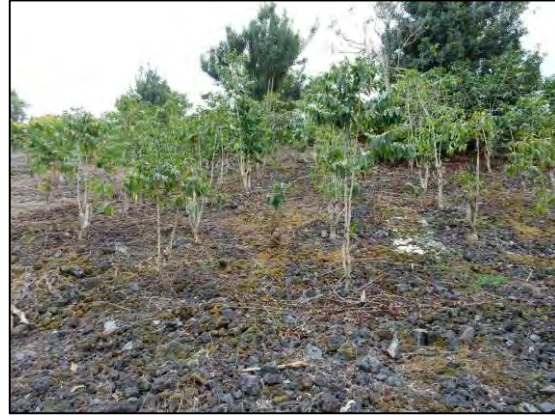
This is a coffee orchard with trees growing out of rocks. The brownish substance on the surface is either moss or leaf litter, it is not soil.

This field is not fenced. If the cooperators were to begin improving the health of the soil here visits from feral pigs would be of no surprise.

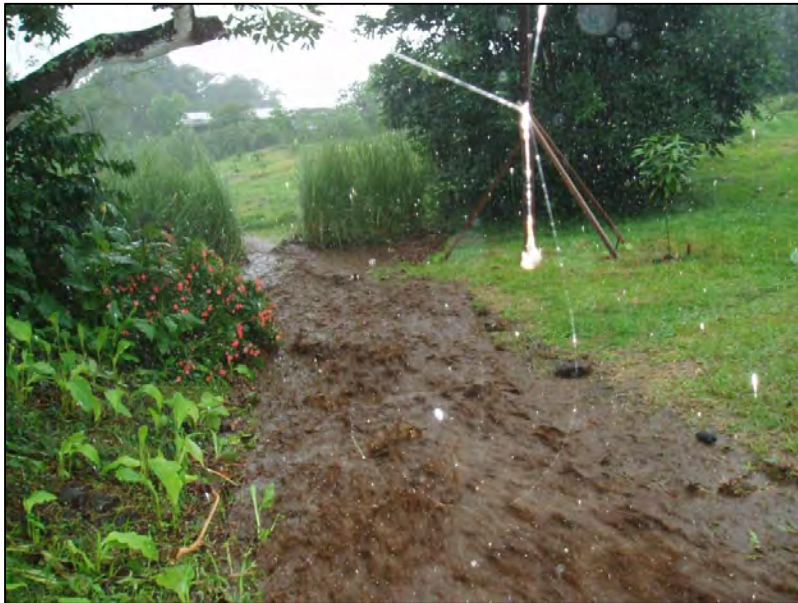
This is a flash flood brought on by 7 inches of rain in approximately 3 hours. The farm, thankfully, had a fence. Virtually the entire farm has conservation cover. The tall grass through which the water is flowing is vetiver, planted to slow the flow of flood water. Please note the brown color to the water.

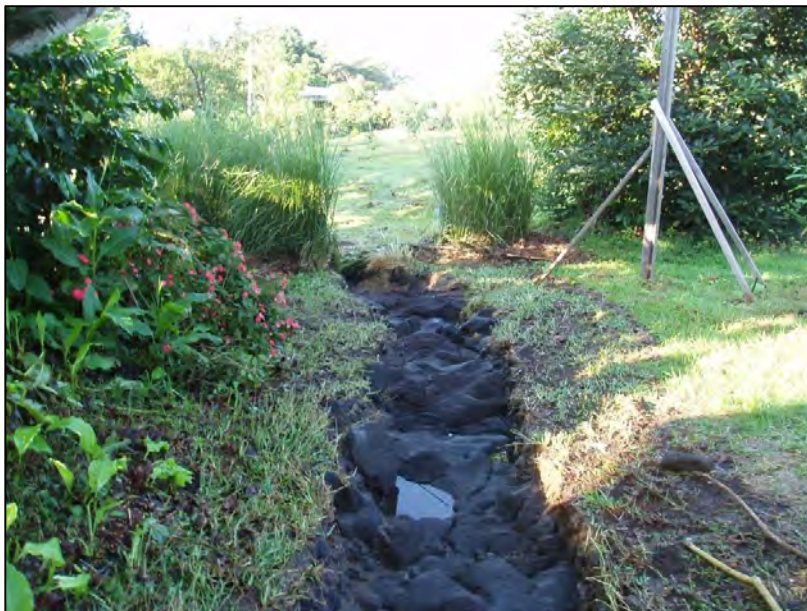
When the muddy river flow finally stopped the farmer was left with this, soil removed to the impervious layer. This photo clearly shows how shallow our soils are. This runs from one end of the property to the other.

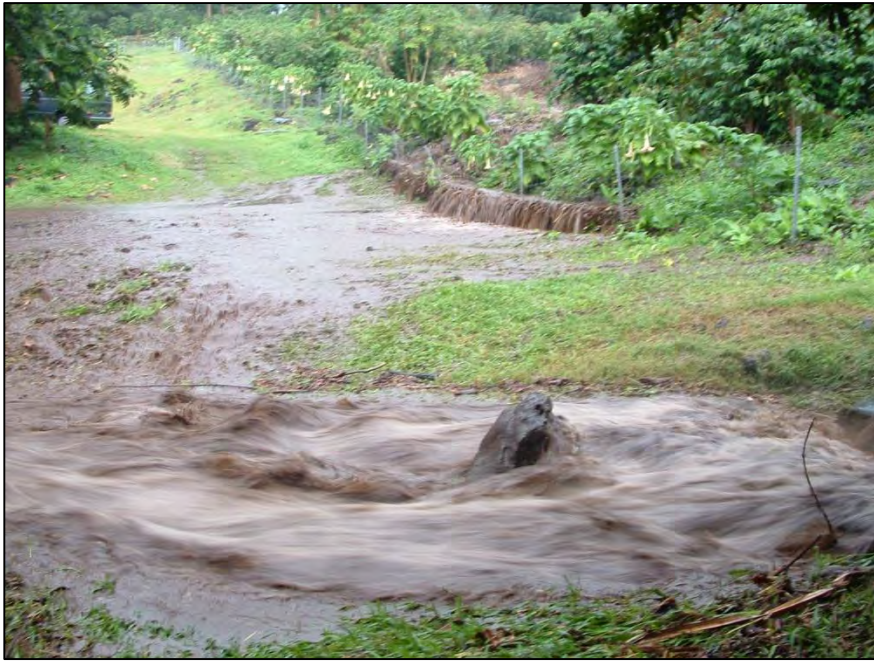
The water flowing in the bottom of the photo is the channelized flow that cut through the vetiver grass shown in a previous photo. The water flow in the center of the photo is a sheet flow. In the background you can see the extent of the conservation cover on this farm.

The fence also prevented larger lava rocks from being part of the sheet flow. If there were large rocks in the sheet flow the integrity of the conservation cover would have been negated by the holes the rocks would have created. Those holes to the cover would have allowed the water access to the soil underneath thereby increasing the erosion on this land.

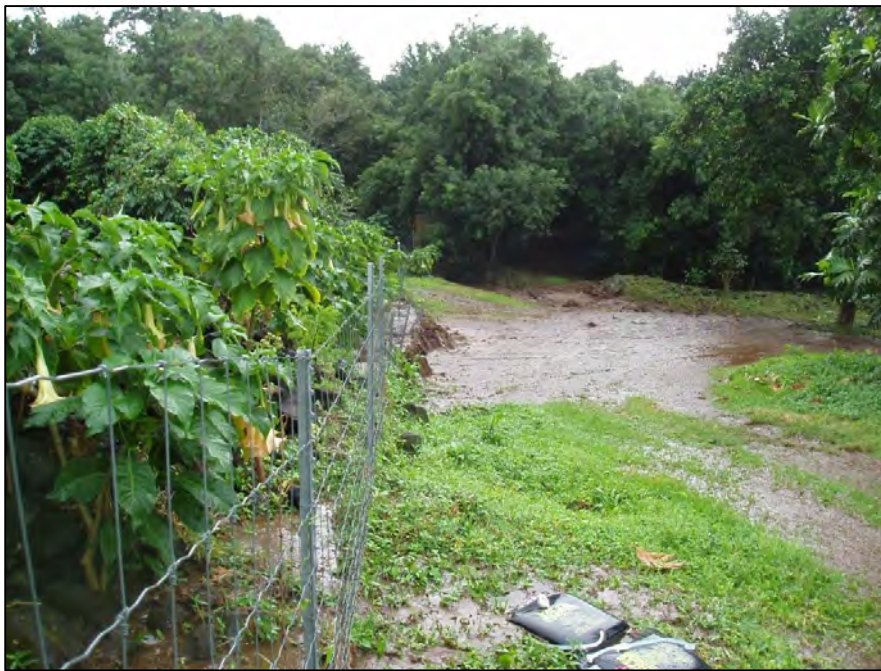
The land in the photo is the same as the previous one but taken from the north side of the sheet flow.

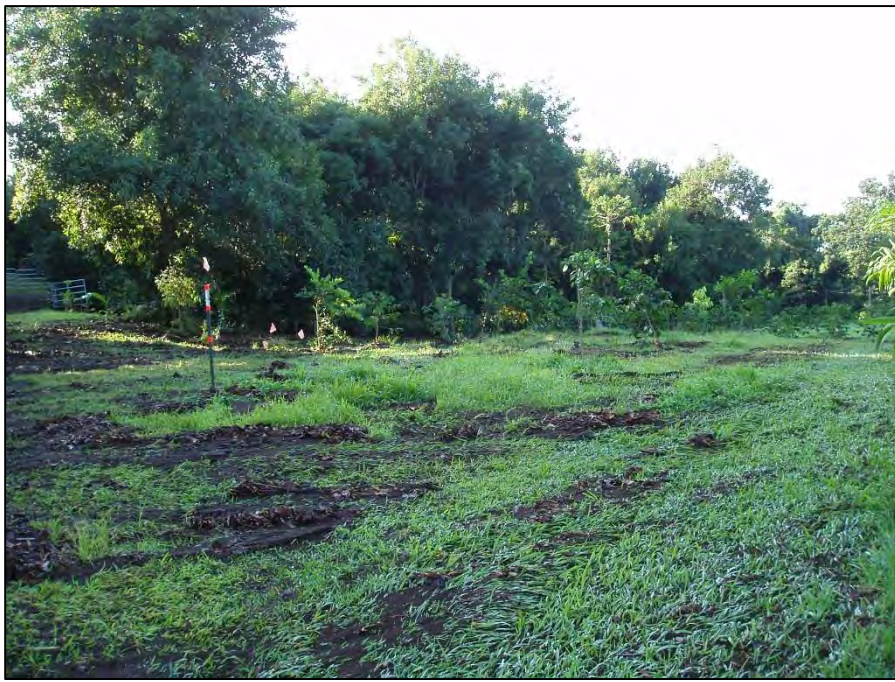
This is on the same farm as the previous four photos. This is the day after the flash flood. Thankfully these farmers value their soil and keep it covered.

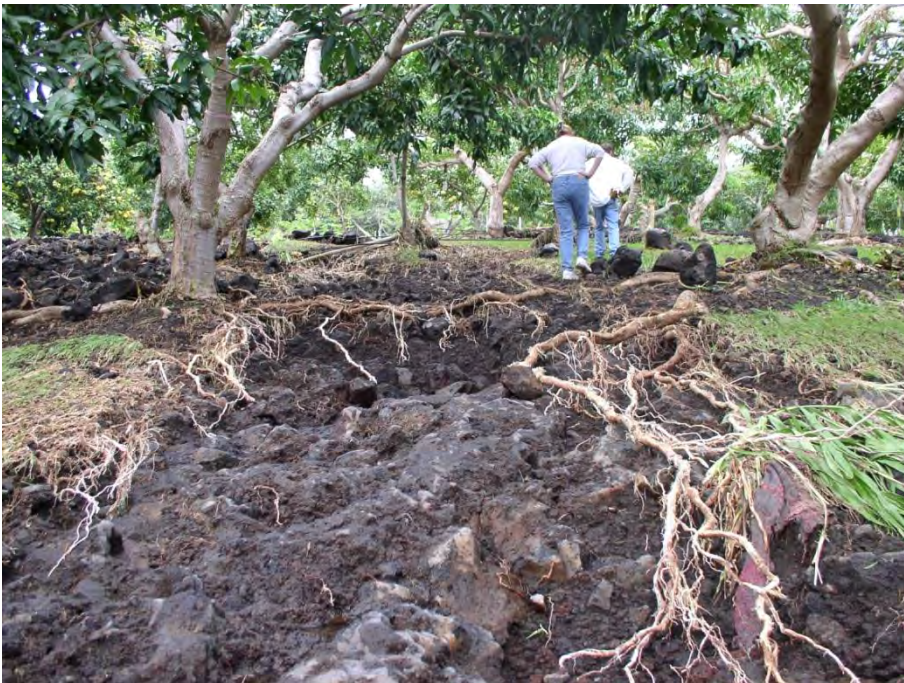
Thanksgiving 2007 rain and flash flood event. Again, we see on this farm just how shallow the soils within the Kona SWCD are.

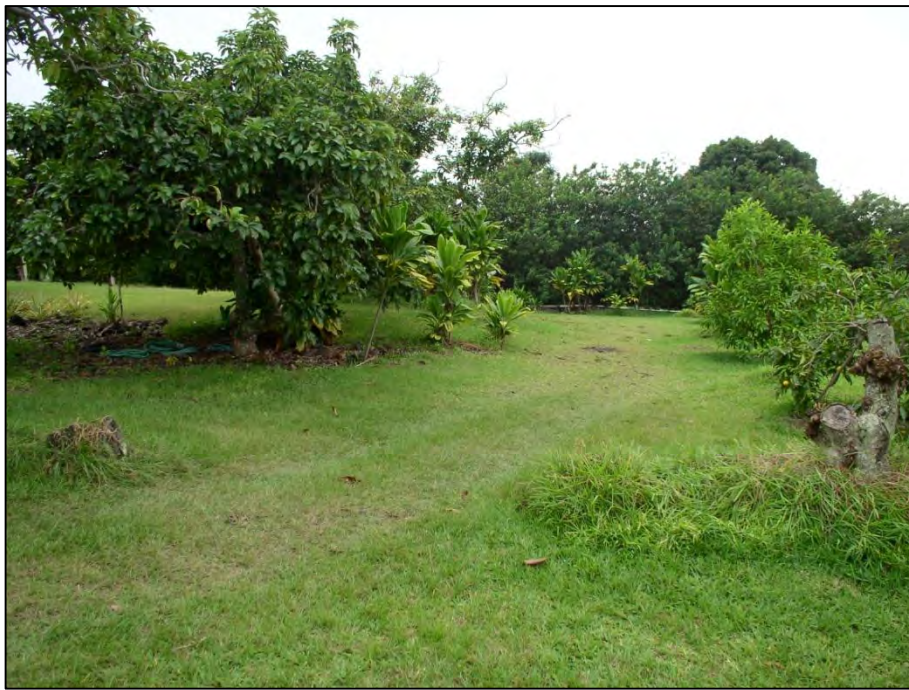
This photo was taken on the same day and from the same spot on the same farm to show the condition of the entire farm prior to this flash flood, conservation cover throughout. The farmer does this to protect his soil. Under the tree in the left center of the image you can see where some debris from the flood has accumulated. If pigs had tilled the soil in this area of the farm it too may have washed away to the impervious layer.

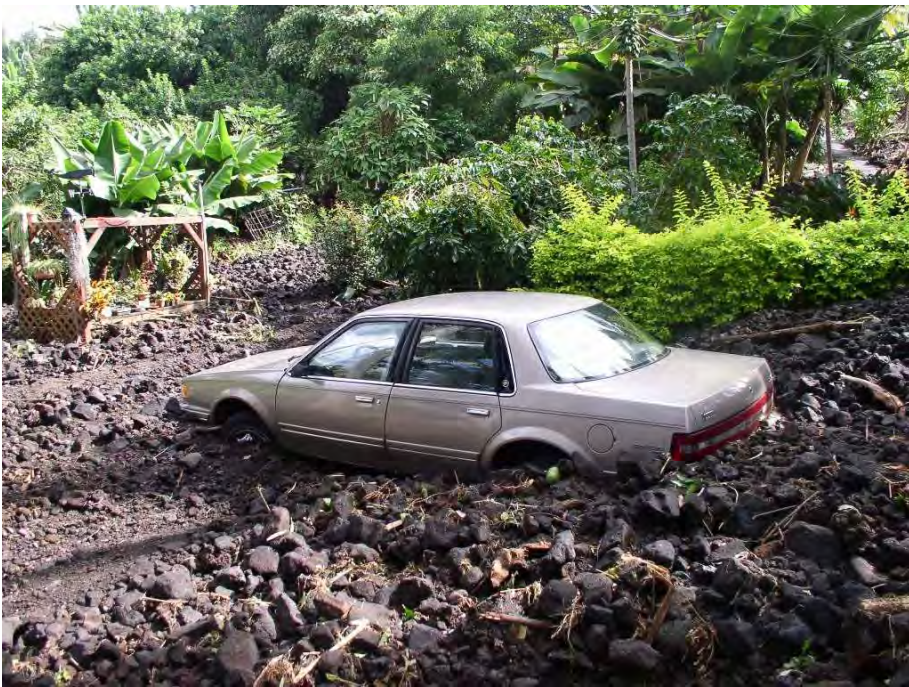
As these rocks came down with the flow of water. First they crossed the farm slamming into the conservation cover doing the terrible damage shown in the photo above, then they crossed Mamalahoa Hwy and came down through this farm located across the street. As you can see many of the rocks finally came to rest in the driveway.

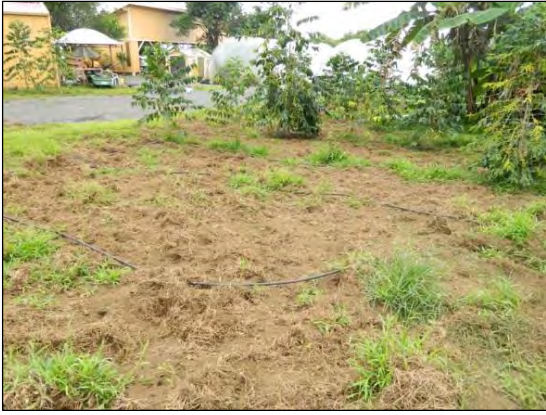
Description: This is the same farm as shown on the previous page. This farm was particularly hard hit.

More feral pig damage caused by tilling soil. There was no damage to crop on this farm, the damage was to soil and the irrigation system.

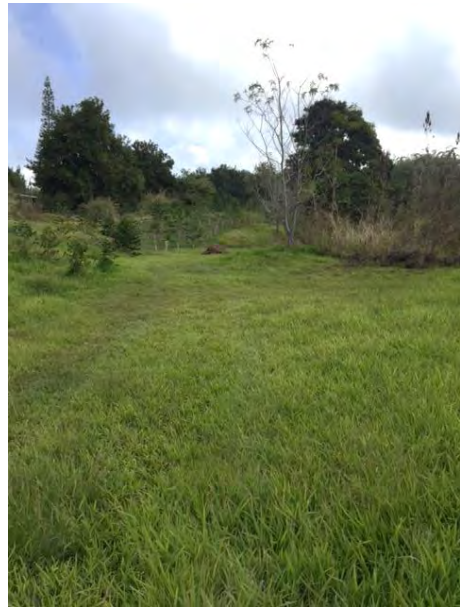
Description: Fortunately this farmer was able to obtain a fence with financial assistance through EQIP. You can see the coffee trees in the background as well as what looks like a pile of mulch.

There is a significant improvement to the soil health on this farm now that there is nothing coming onto the land to destroy it, namely feral pigs. If we want to protect our soils and keep them on our farms this is the solution.

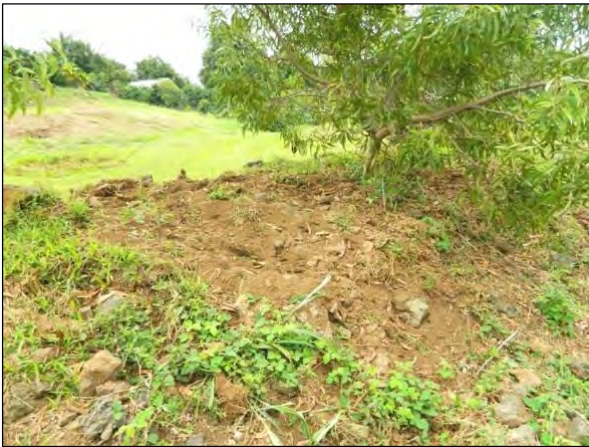
Description: More feral pig damage. In this photo they tilled land adjacent to a water course. You can see additional damage toward the upper left corner of the photo

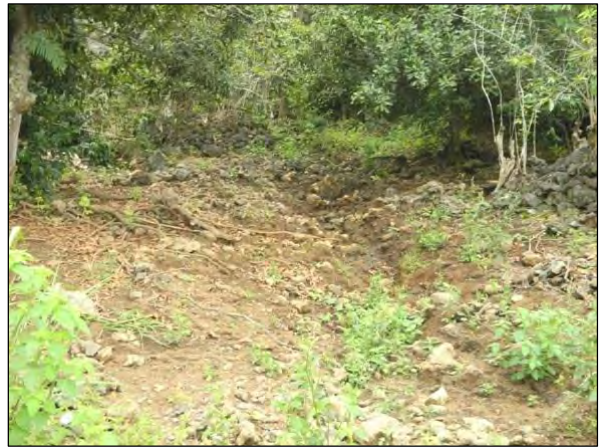
Description: Feral pigs tilling the soil provides this as a result. This is an area where water flows onto this property during significant rain events.

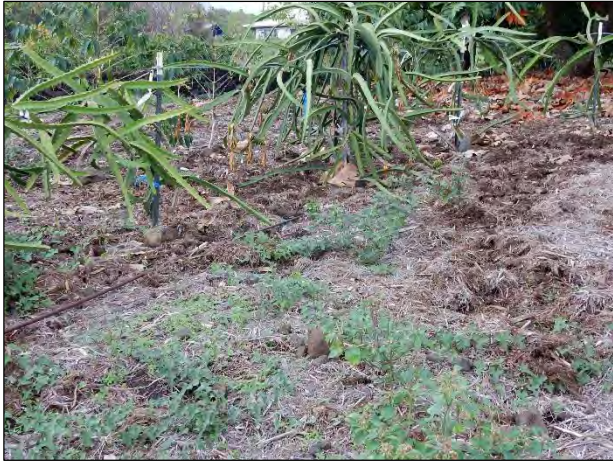
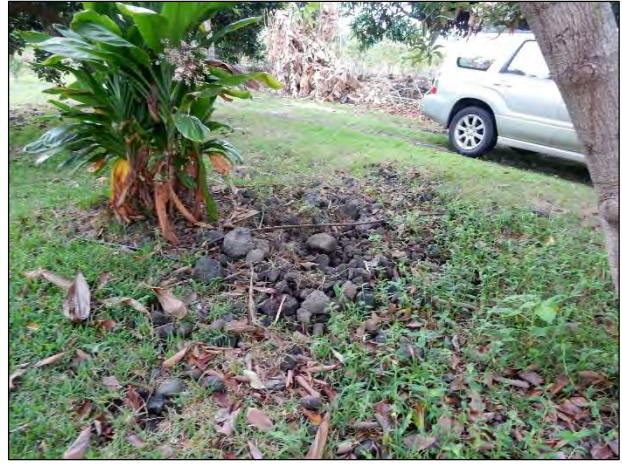
This shows feral pig damage to a recently mulched field. The installation was with financial assistance from NRCS. The crop, dragonfruit, was left alone, the pigs went after the mulch. They have also caused some damage to a recently completed irrigation system, also installed with financial assistance from NRCS. The cooperater reports an additional 30-40 hours of work is required to fix this but he is discouraged because he believes within just a couple of days it will be tilled again.

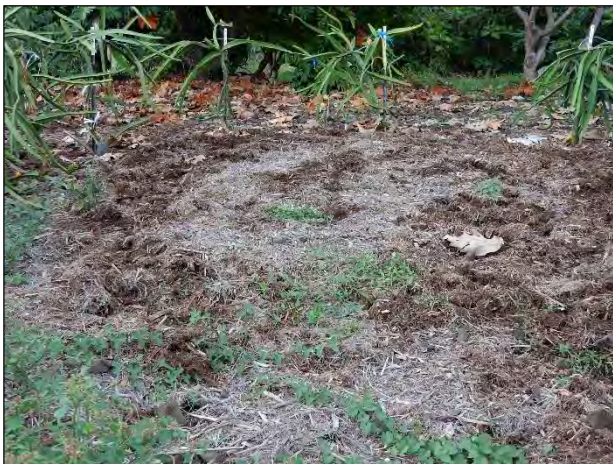
Description: Feral pigs created their own on-site resting place. This photo the previous photo and the next photo are from a 12.57 acre farm with three soil MUSYMs on it, all with a T Factor of 1 and all with a slope of 2-10%.

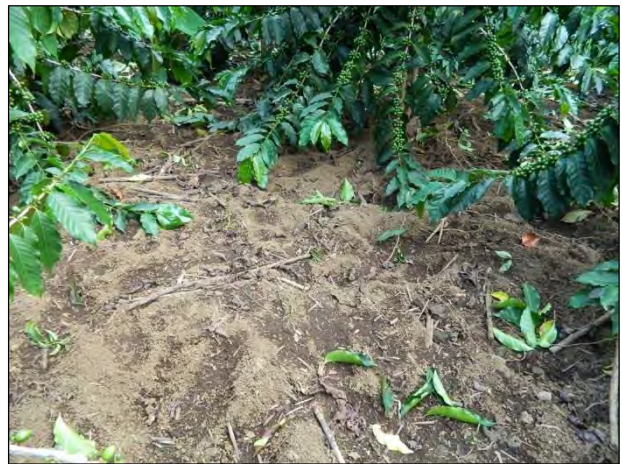
Description: Feral pigs simply tear up mulch in their quest to find tasty tidbits.

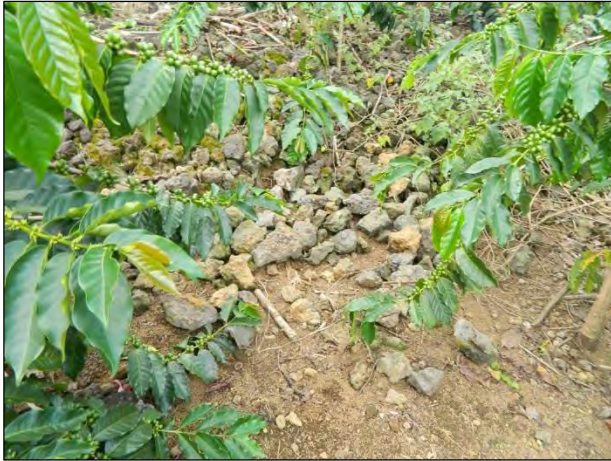
Description: These rocks were part of a rock wall that went along one side of the farm. The wall, for all intents and purposes has been flattened.

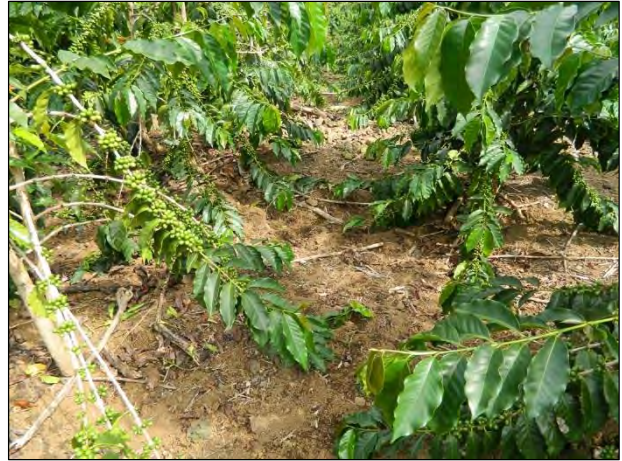
Description: more feral pigs damage in the form of tilling soils.

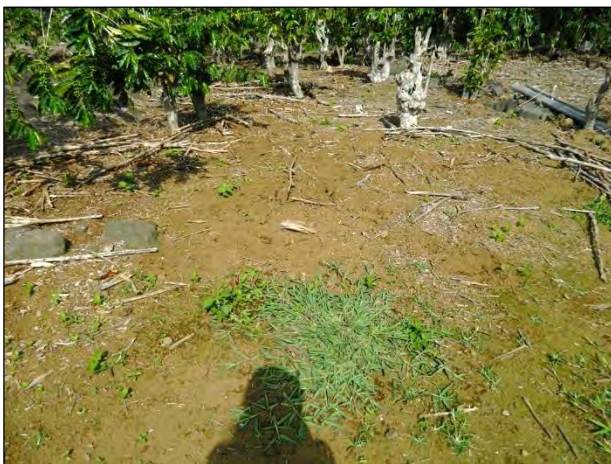
Description: More soil tilling by feral pigs. The cooperater was trying to establish conservation cover but found it to be losing battle because of the feral pigs.

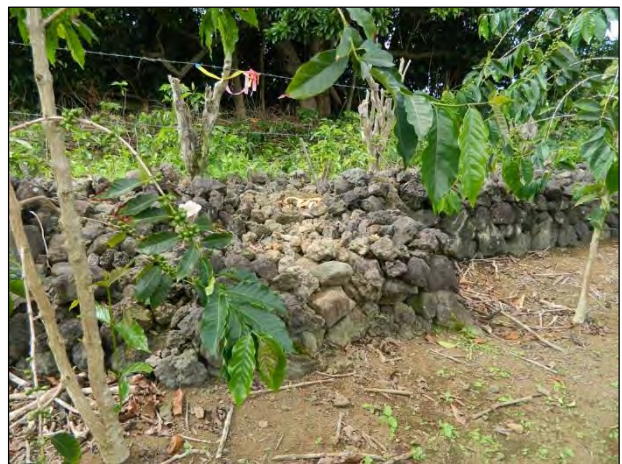
Description: The discolored area on the rocks is an access point for feral pigs.

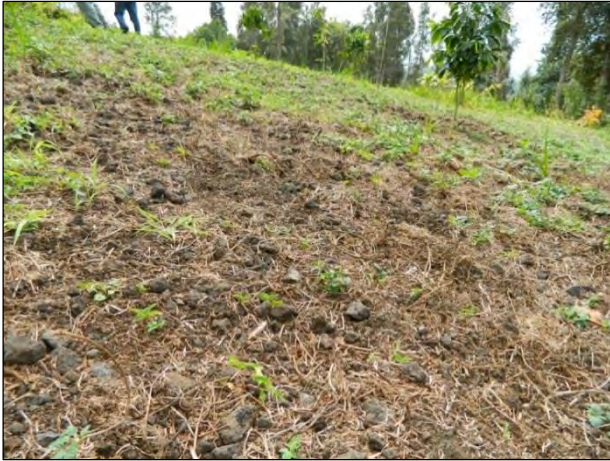
Tilling soil in Kona is done by feral pigs, as shown in this photo.

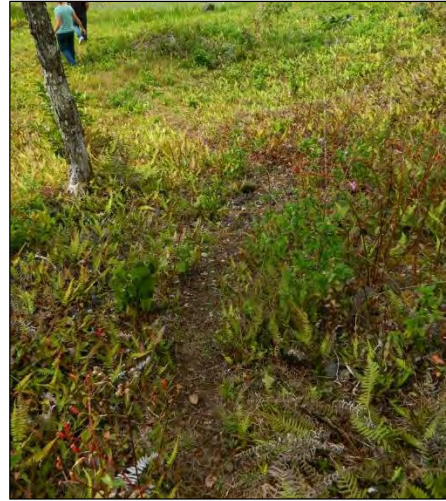
Description: This is a trail created by feral pigs.

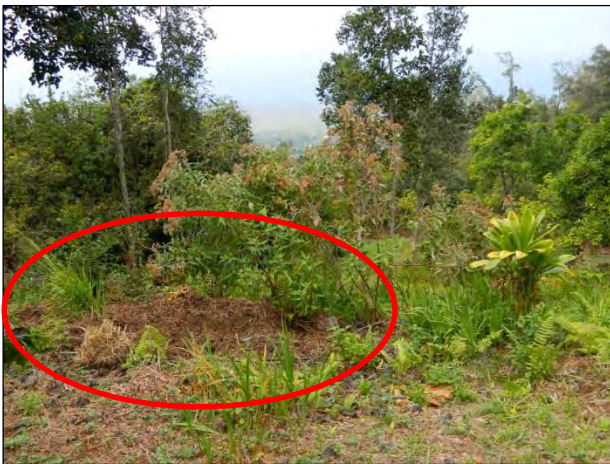
Description: tilling of soil and mulch by feral pigs.

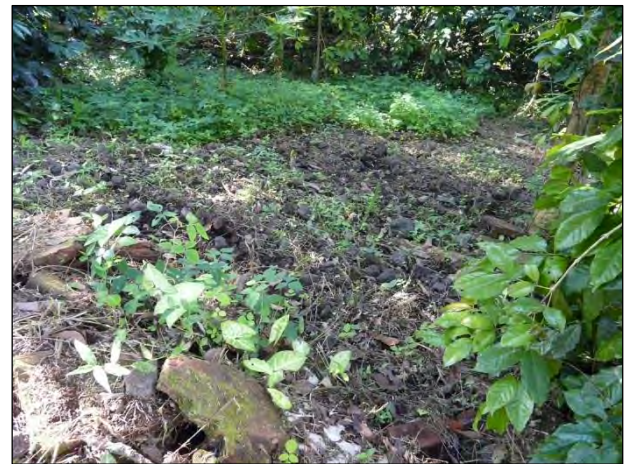
Description: There has been little to no crop damage on this farm. The only damage that has taken place has been to the soil, the tilling of it by feral pigs. There are farms that have lost orchard trees because of the disturbance to the soil underneath them.

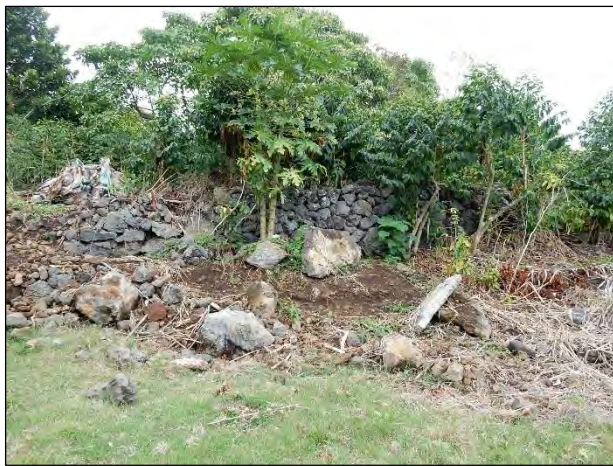
This was a complete rock wall and the conservation cover went up to the wall...until the feral pigs started to till the land. The parcel shown on this page has two soils. One of the MUSYMs has a T Factor of 2 with slopes of between 20 & 40%, the other soil has a T Factor of 1 with slopes between 20 & 40%

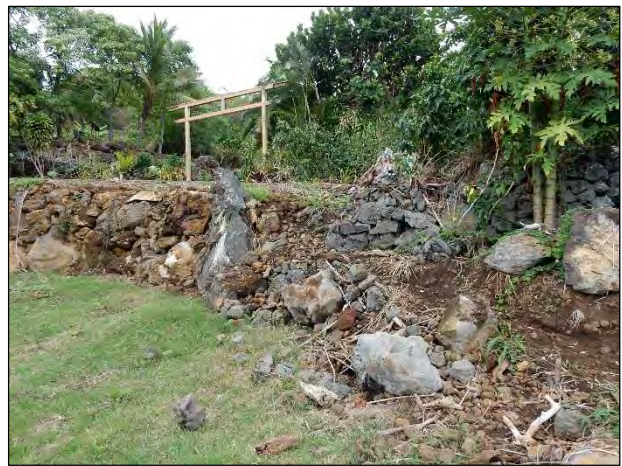
Description: This is another view of what tilled soil looks like when feral pigs are doing the tilling.

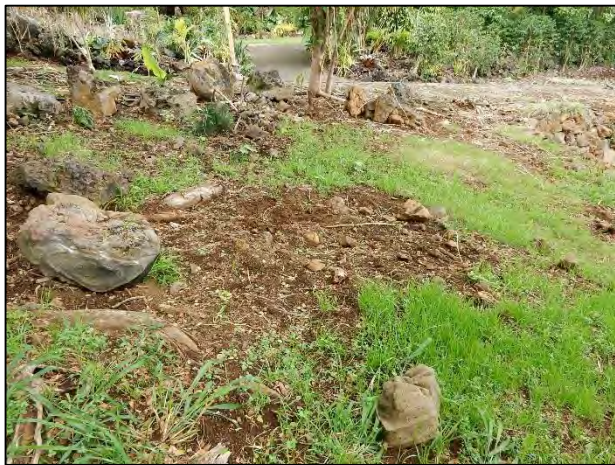
Description: This is another view of the previous two photos. The damage shown here continues down the slope to the area shown in the next photo.

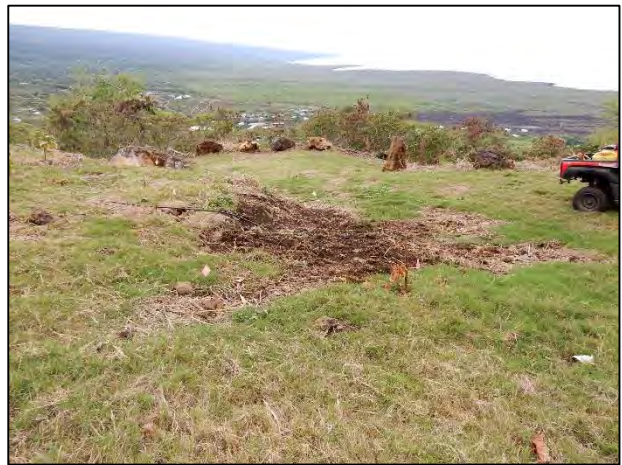
Description: This is very near the area in the shown in the last three photos and at one time was also, like the area above it, totally covered with conservation cover

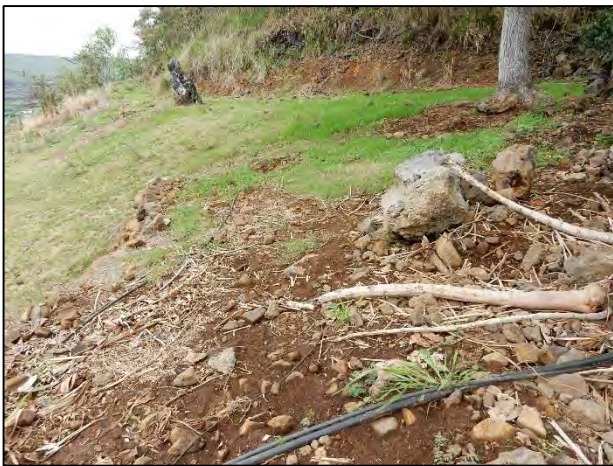
Description: more soil tilling by feral pigs. This area of tilled soil is very near the areas shown in the previous 4 photos but is its own distinct example of tilling. This photo is from the same parcel as those on the previous page.

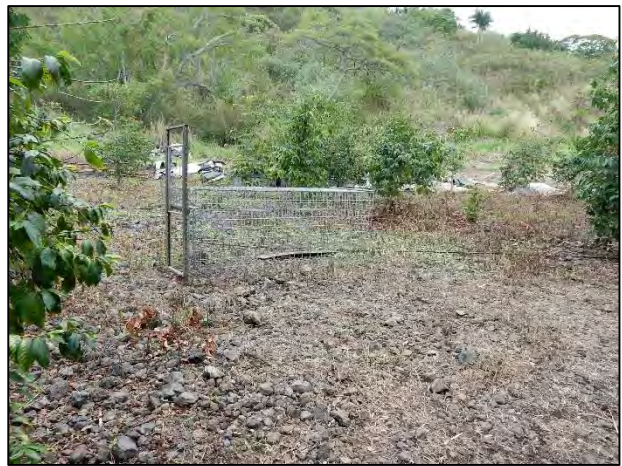
A pig trap used by a local cooperador in their attempt to control feral pig populations on their land. They have been unsuccessful. This photo, and the following five photos are from a farm with soil that has a T Factor of 2 and slope of between 20-40%.

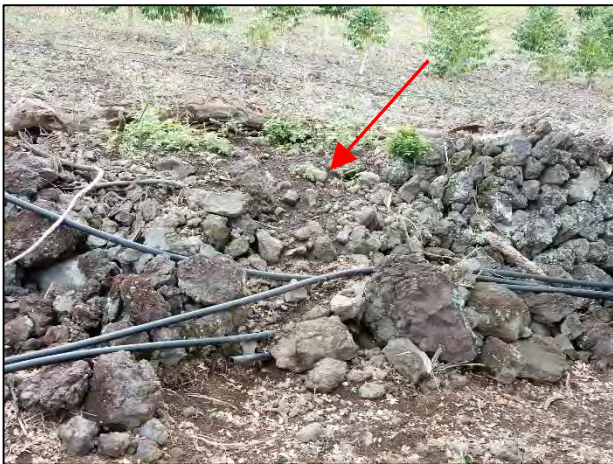
Description: A feral pig trail that has damaged a rock wall. The NRCS cost shared irrigation system on this farm has also been damaged by feral pigs.

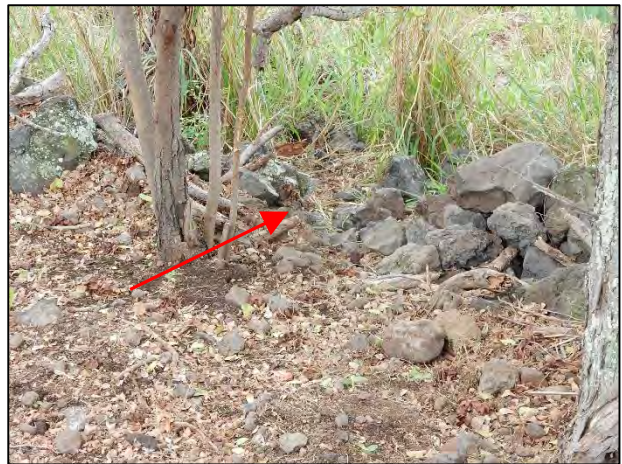
Description: The center of this photo shows another part of the trail shown in the previous photo. These trails are across the driveway from each other so it part of the feral pig transportation system.

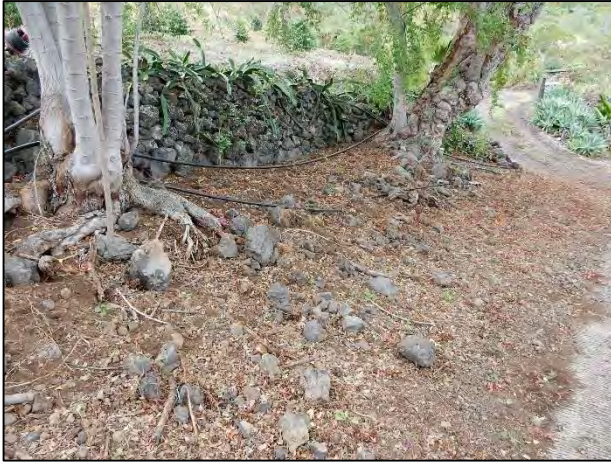
The cooperater has pretty much given up putting these rocks back.

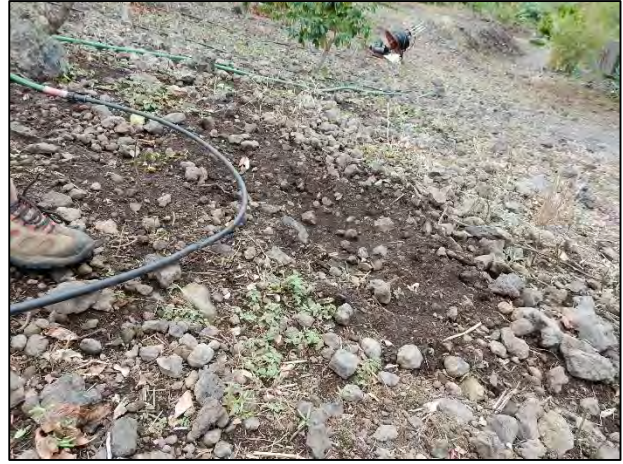
Description: Feral pig damage from tilling and damage to the NRCS cost shared irrigation system.

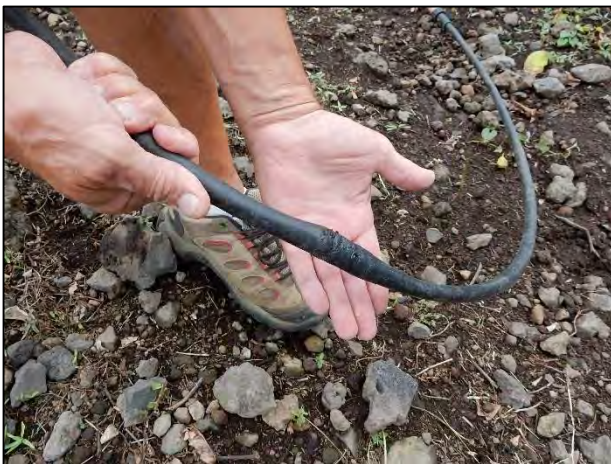
Description: Damage to the irrigation system. The cooperater believes this was a juvenile pig that did this. It is believed an adult pigs would have bitten right through and created a tremendous water leak. This cooperater only irrigates during the day and will shut the system down at 4pm.

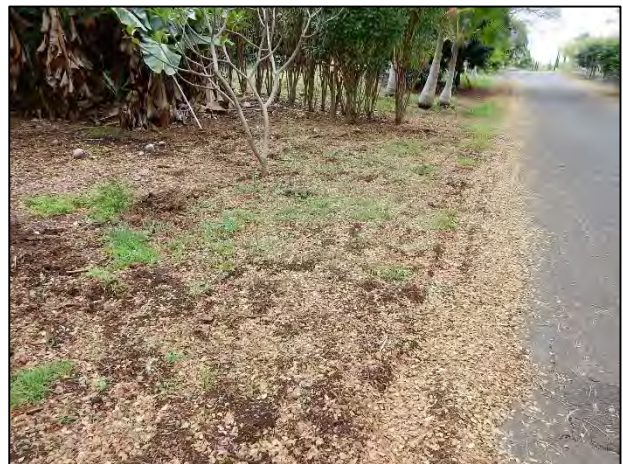
Tilling of soil along a road by feral pigs. The Army Corp of Engineers, in a draft flood study to update flood maps in S. Kona, describes this road as a watercourse during flood events.

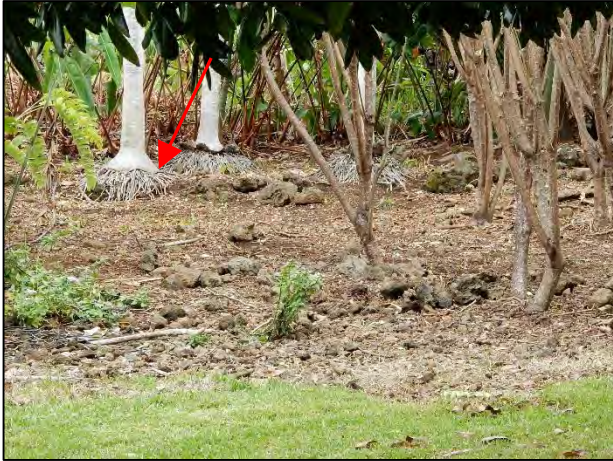
Description: Ten to twelve years ago this area could be mowed with a sit down mower then the pigs started tilling soil and unearthing rocks. The soil tilling has resulted in a great deal of erosion as can be seen by the palm tree roots.

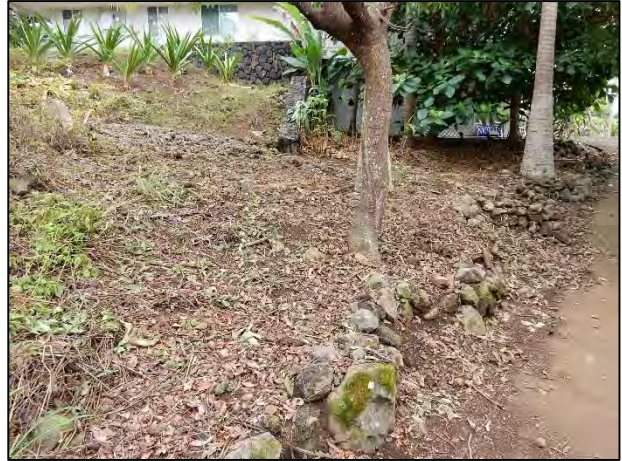
Description: There used to be a rock wall and grass cover here, until the feral pigs started doing their work.

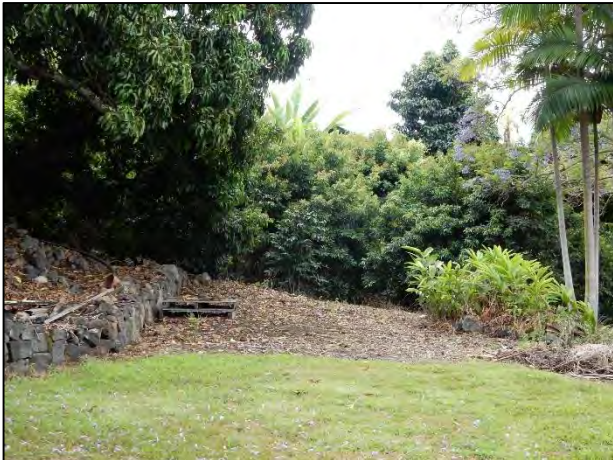
Description: The grass cover in this photo extended all the way back to where the trees are and continued down the slope along the southern edge the property. This area was also maintained with a sit down mower until the erosion and rocks being unearthed and moved about made it too dangerous.

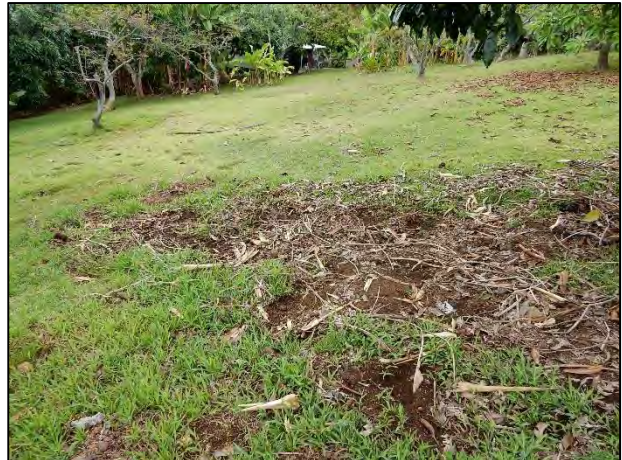
Description: The tilled soil in the photo is directly across the street from the previous photo, therefore along a proposed Army Corp of Engineers proposed watercourse in the event of flooding.

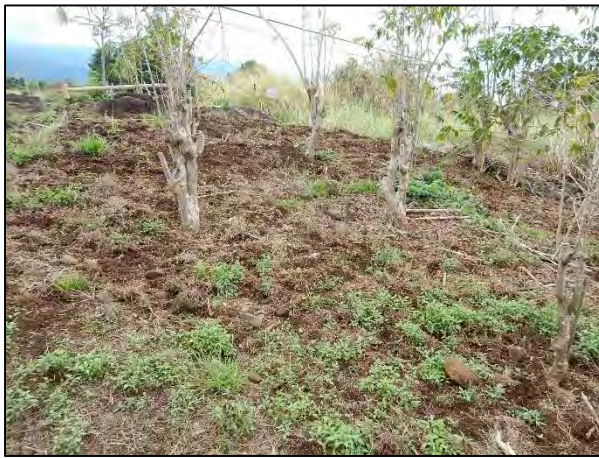
What land looks like when feral pigs till soil. It is now ready for erosion. This parcel is fenced but some pigs did gain access due to carelessness of the farmer. Now that the farmer has seen just what kind of damage can be done by the feral pigs there is no more carelessness.

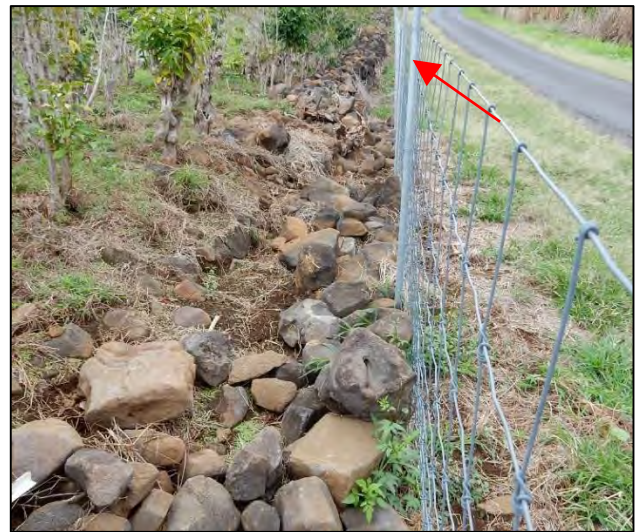
Description: This was a very nice rock wall, one that has been here for years, as can be seen at the top center of the photo, until the feral pigs decided there was something under it they wanted.

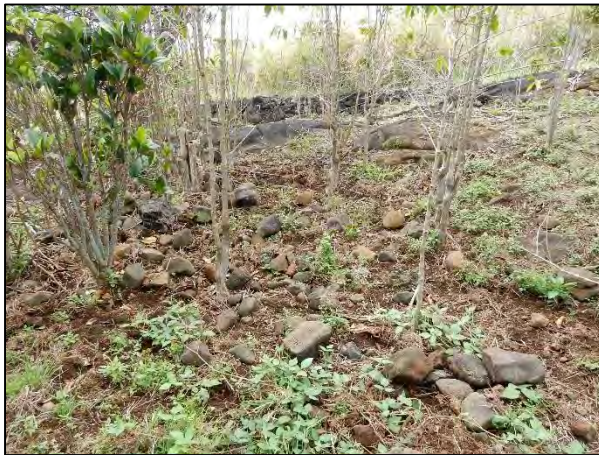
Description: Soil tilled, rocks unearthed, land is now ready for erosion and invasive species establishment.

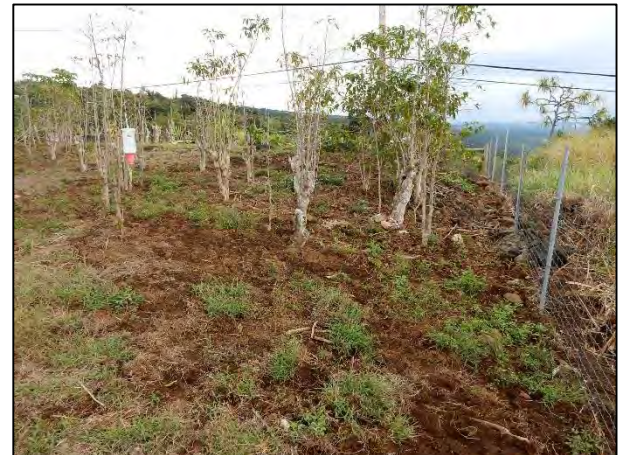
Description: More soil tilling done by feral pigs.

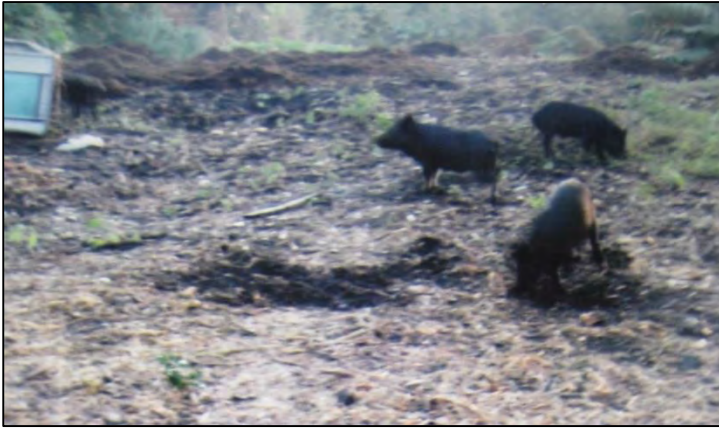
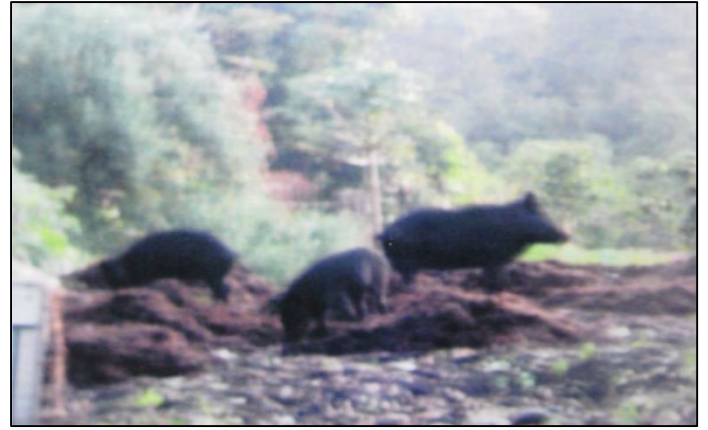
The cooperater farming this land is under contract with NRCS to improve soil organic matter by applying mulch. Every time mulch is delivered feral pigs destroy the pile and have made it impossible for her to complete the contract item. She is about to cancel the contract because she cannot afford to fence her cropland. As a result her soil health will continue to degrade.
